Pait Home Inspections of North Carolina, LLC
(919) 675-4095
paitinspections.com

Pre-Drywall Inspection Report

123 Pre-drywall Rd
Wake Forest, NC 27587

Prepared For: Happy Client
Inspected On Fri, Sep 8, 2023 at 8:56 AM

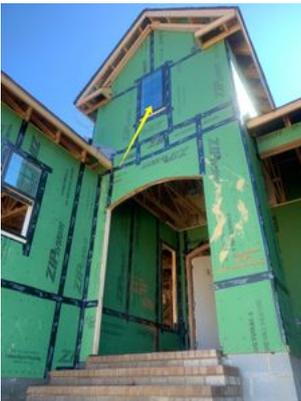
Comment 1

The front entryway gable picture window is broken and requires replacement.

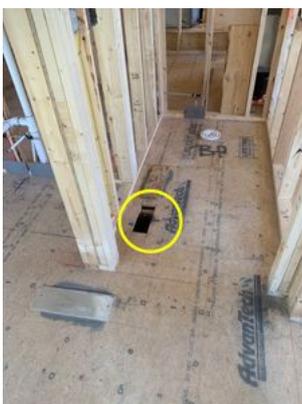
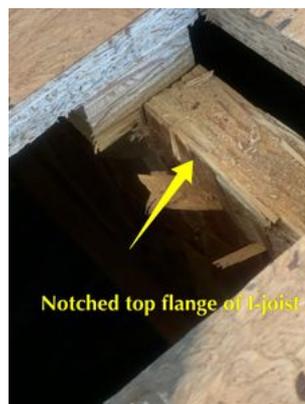
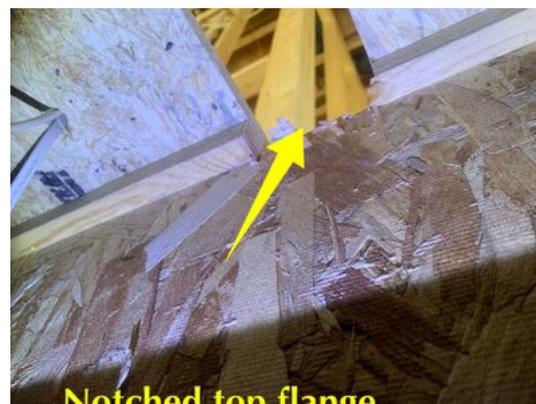
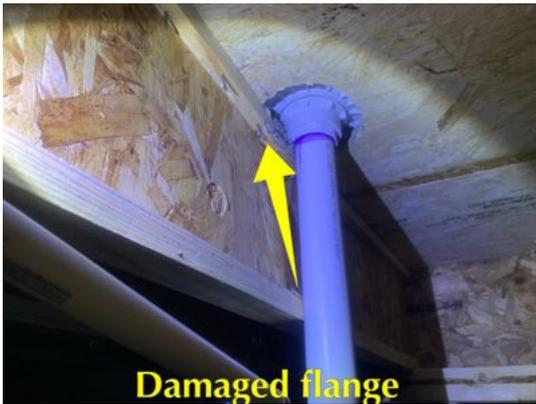
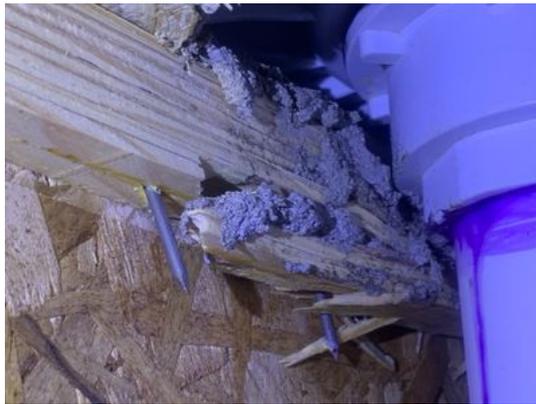
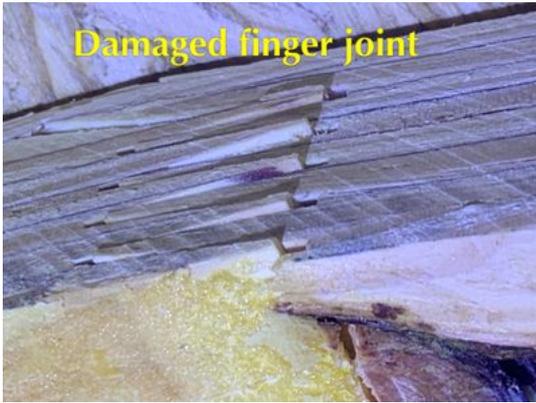
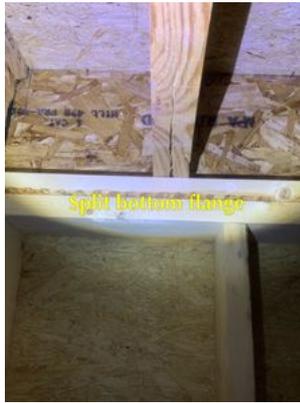
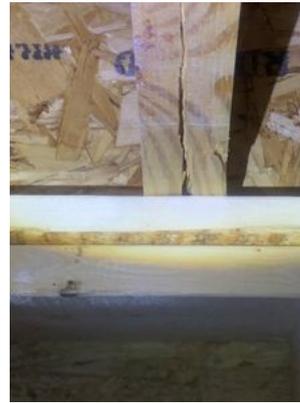
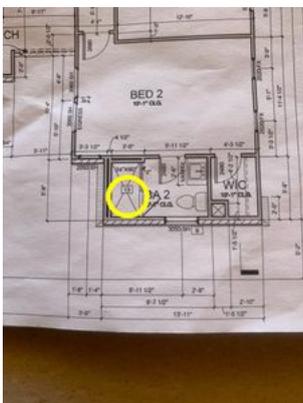
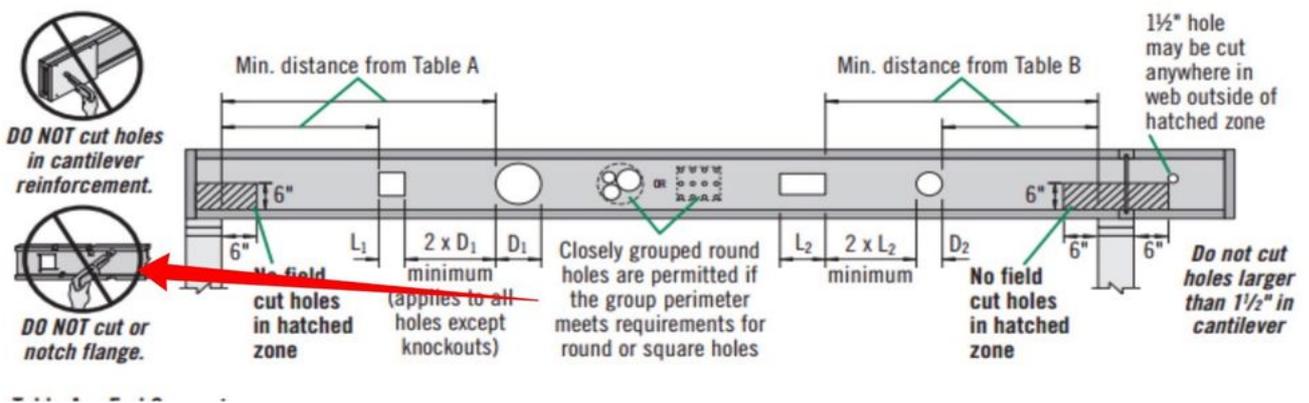
Comment 3

A top flange on a floor framing I-joists is has been notched to accommodate an HVAC vent in the master water closet.

Additionally, a floor I-joist has been damaged during the installation of the front right bathroom shower drain line.

I-joists are engineered components. When damaged or improperly altered, this can effect structural integrity of the floor system and could cause the floor to sag. Because I-joists are engineered components, typical building guidelines specify that and damaged components must be repaired and repairs or alterations must be designed by a registered design professional. In most cases that would be a Licensed Professional Engineer with experience in designing repairs or alterations to to I-joists. It is recommended to obtain a sealed letter from a licensed structural engineer stating that the current conditions of the I-joists are sufficient or get a recommendation to repair any altered truss. This letter will be needed should you ever decide to sell the home.

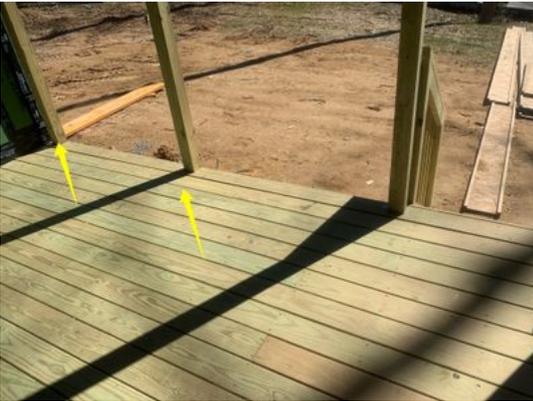
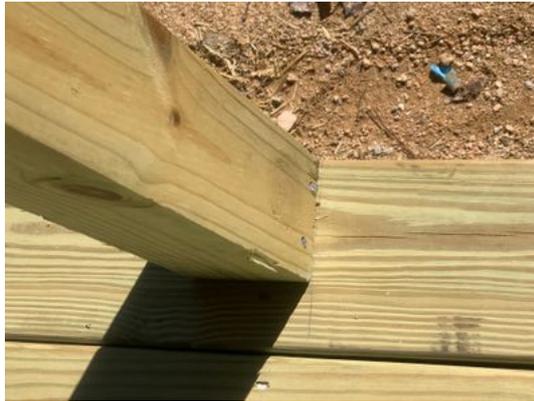
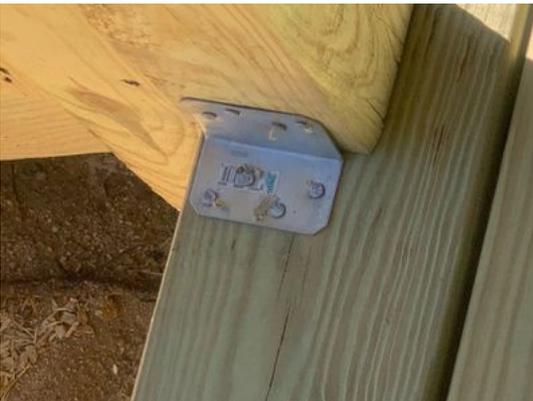
Two back porch columns have not had angle brackets installed to secure the column base to the deck.

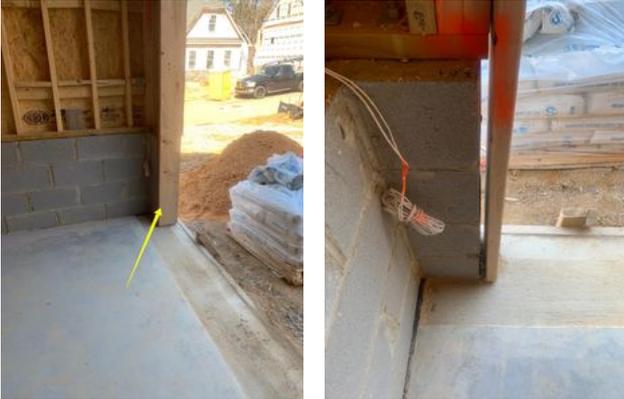
Shimming and securing the garage door opening jamb is recommended to prevent twisting/warping over time.

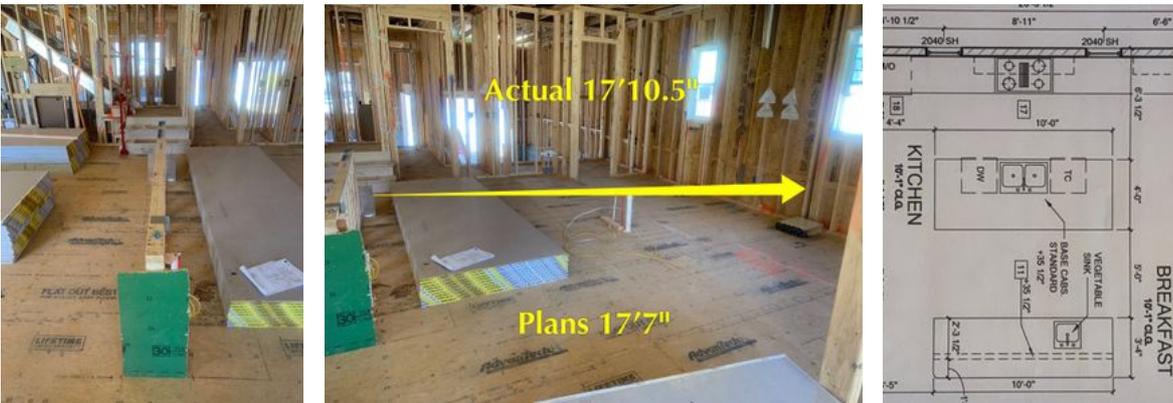
The vegetable sink island is 3.5" inches off per floor plan specifications.

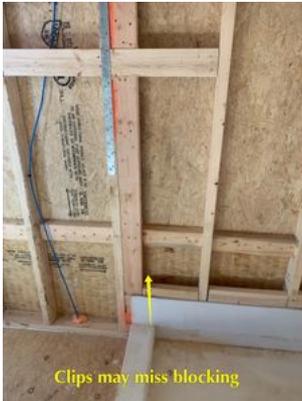
It is recommended to ensure all blocking (deadwood) is installed to span the entire width of the shower curb. This allows the shower door track/clips to be properly secured to the framing as opposed to only the tile/sheetrock.

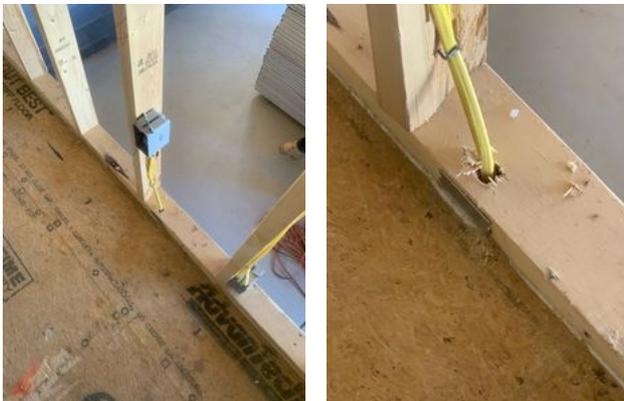
Fire caulking is missing in multiple penetrations. Ensure all holes are properly sealed.

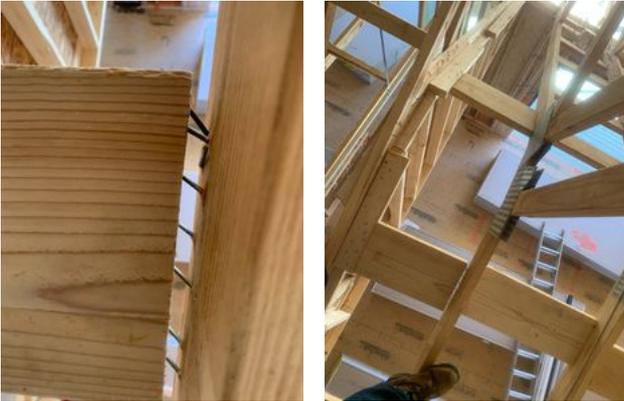
Comment 10

Any of the faux beam blocking with greater than 3/8" gap should be blocked to ensure they are properly secured. Too large of gaps will prevent the fasteners from properly securing the blocking and can lead to possible sagging/loosening over time.

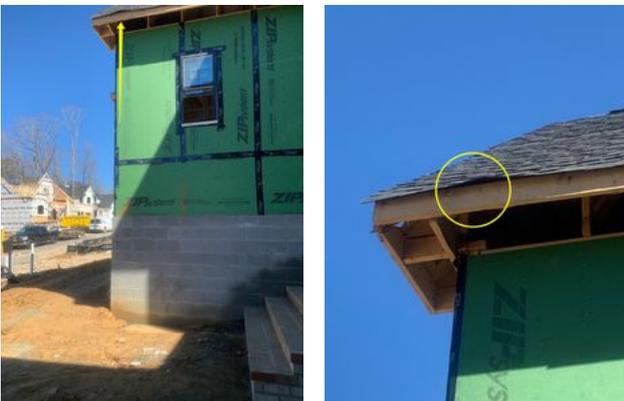
Comment 11

Remove a nail installed on top of the sub fascia prevent damage to the overlapping shingle above the front entry.

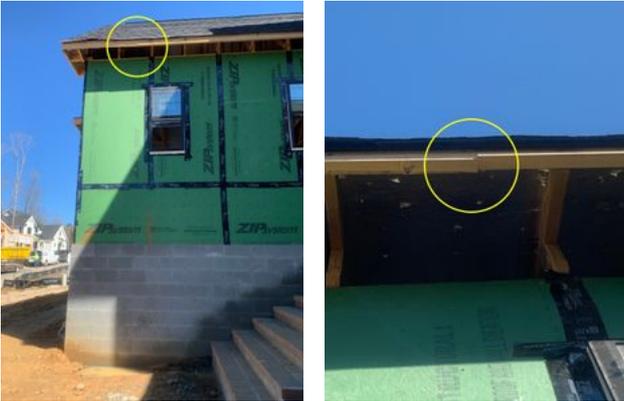
Installing blocking behind any fascia splice/joint that does not break on a rafter tail or outlook is recommended to prevent differential movement of the splice over time which could affect the final fascia install and appearance. A joint at the front entry fascia is not blocked. All other areas are blocked properly.

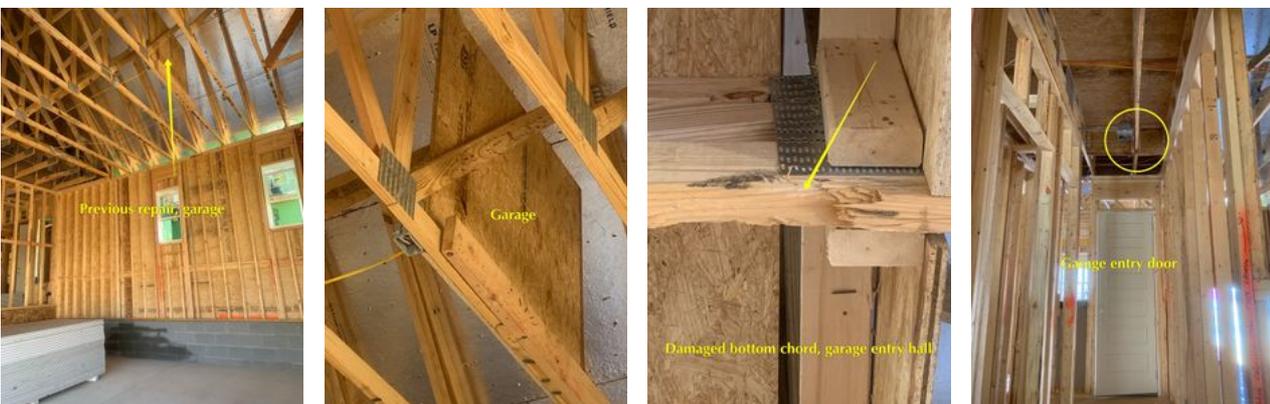
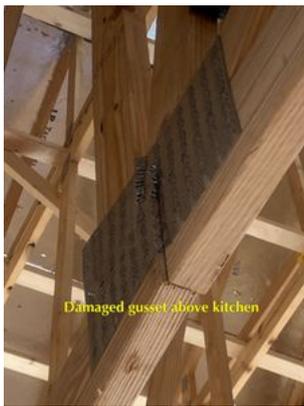
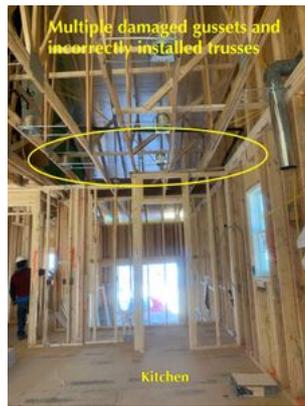
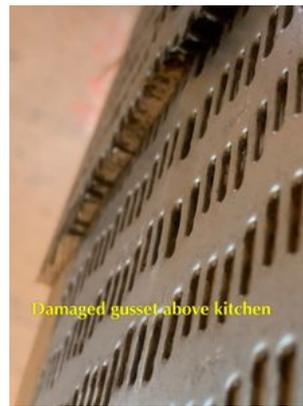
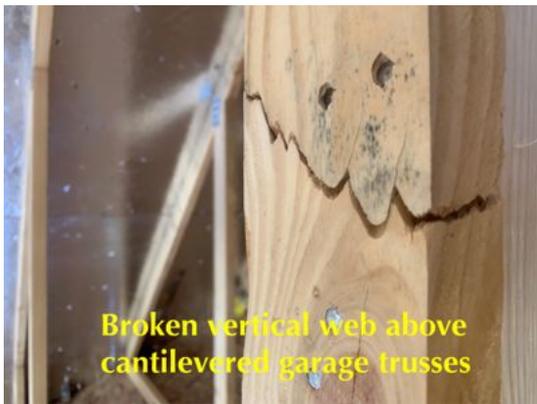
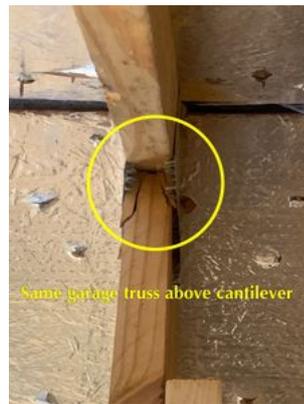
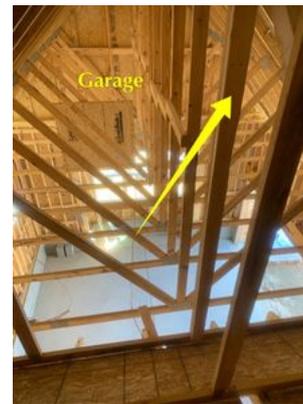
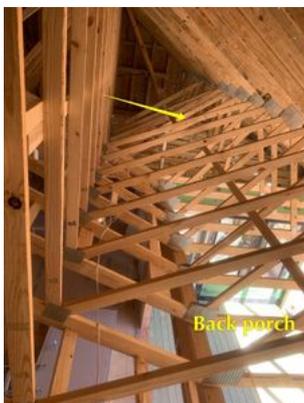
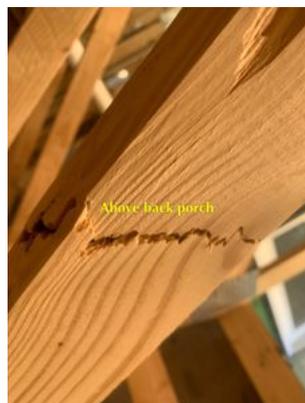
Alterations, repairs, cuts, notches and holes bored in trusses are not permitted unless the effects of such penetrations are specifically considered in the design of the member. There are multiple altered, damaged, repaired and/or modified attic trusses.

Trusses are engineered components. When damaged or altered, this can effect structural integrity of the system. Localized damage/cutting to one or two trusses will typically not result in structural failure, but could cause the roof to sag. Because trusses are engineered components, typical building guidelines specify that repairs or alterations must be designed by a registered design professional. In most cases that would be a Licensed Professional Engineer with experience in designing repairs or alterations to trusses. It is recommended to obtain a sealed letter from a licensed structural engineer stating that the current conditions of the trusses are sufficient or get a recommendation to repair any altered truss. This letter will be needed should you ever decide to sell the home.

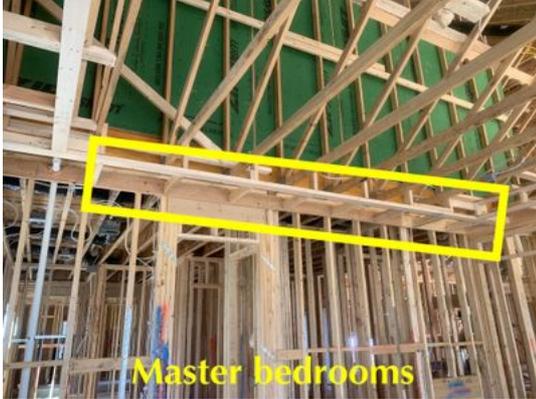
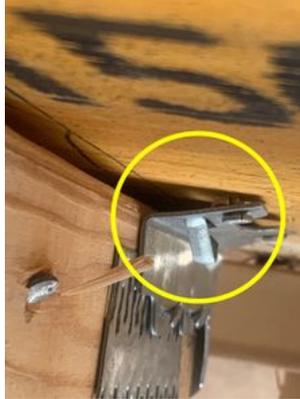
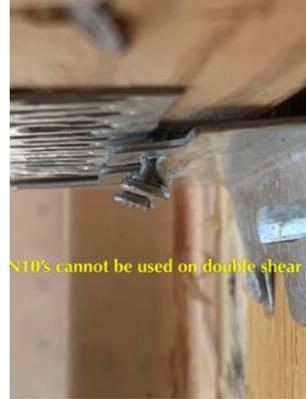
Specific fasteners and installation techniques are required by structural hanger manufacturers. The nails, used to secure the master bedroom attic trusses are incorrect per this installation guidelines. 10d (3-3.5") galvanized commons (or other authorized fastened) are required for use with double sheared installation. N10, commonly referred to as Teco

nails, (1.5" long) are not sufficient and will not give the hanger the properly strength per the hanger manufacturer. It is recommended to properly secure the hangers as required per the manufacturer and install the appropriate sized and type of fasteners to avoid any potential issue in the future.

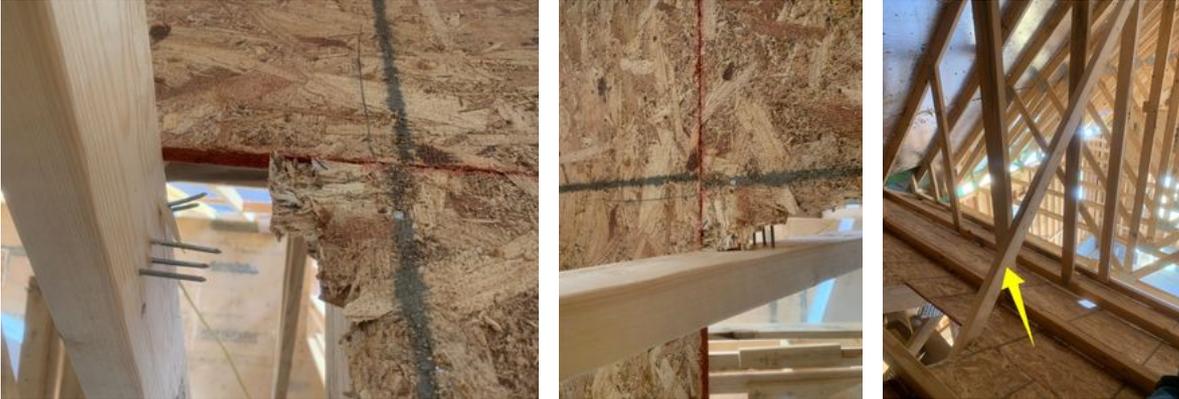
The diagonal bracing of the garage roof trusses is not secured where it ties into the main house roofline.

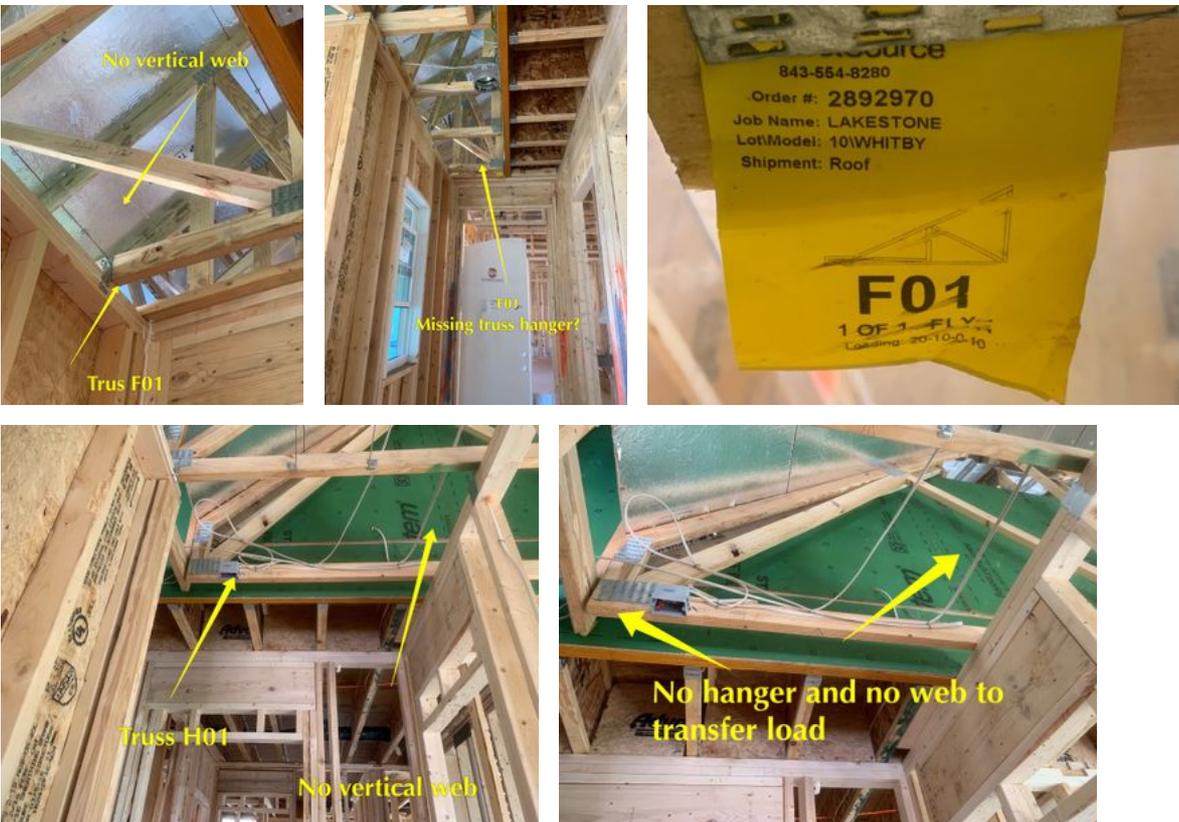
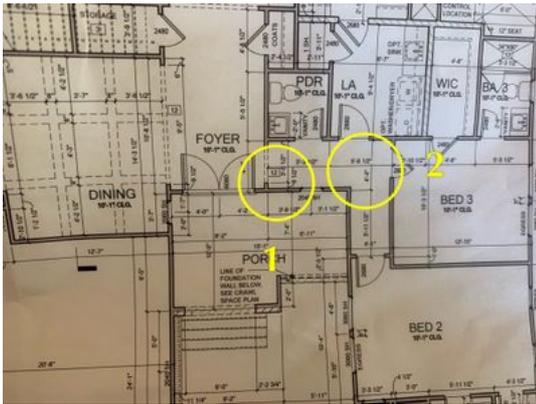
Further evaluation is recommended for multiple trusses installed in the front of the home. The trusses appear to be improperly bearing or not have the appropriate truss hanger installed. Consulting the builder/truss manufacturer is recommended to ensure proper installation.

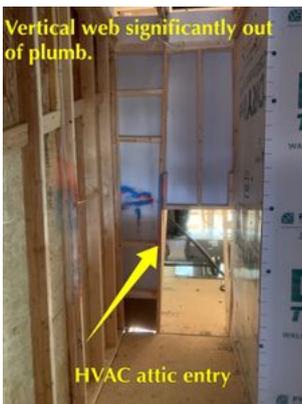
Multiple trusses are installed out of plumb. It is recommended to consult the truss manufacturer to determine the amount of play, if any, is allowed when installing trusses.

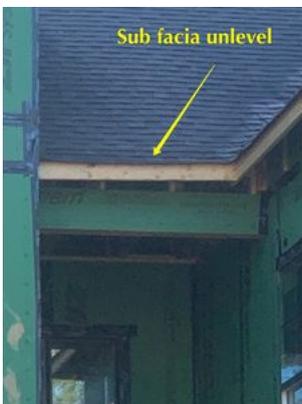
The sub-facia, to the right of the front entry porch is not installed level. Further evaluation and repair is recommended.

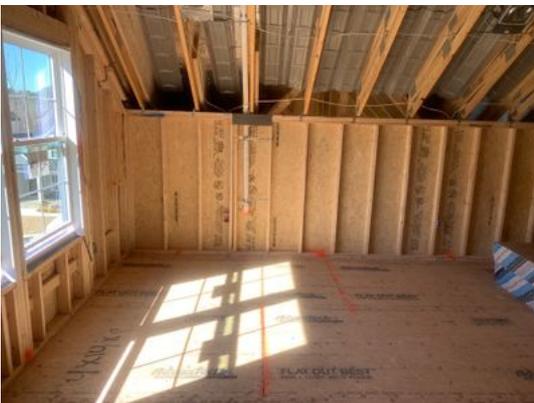
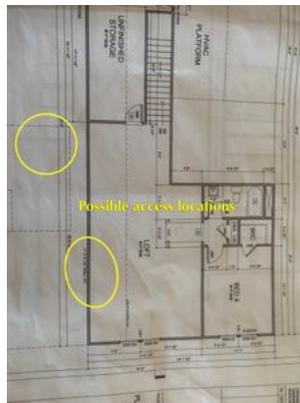
Access to an attic space is required if the the ceiling or roof structure is combustible and sq footage of the attic space is > 30 sq ft and it has a head height of > 30". There is no access for the attic above the first floor, front right bedroom. An attic access is required to allow for inspections and needed repairs. Cutting an access hole no smaller than 22"x30" is required per current building requirements.

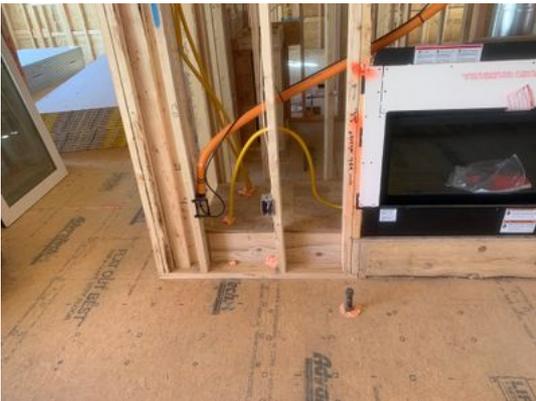
Relocating the low-voltage conduit to behind the built in cabinets to the right of the fireplace is recommended.

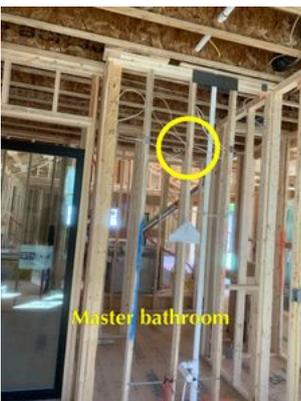
There is a missing nail plate at the master vanity. Nail plates are required anywhere plumbing/electrical hole is closer than 1 1/4" to the face of the framing. This protects the material from possible damage from fasteners.

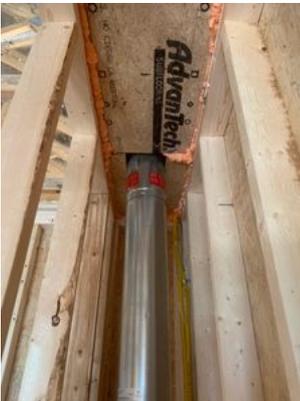
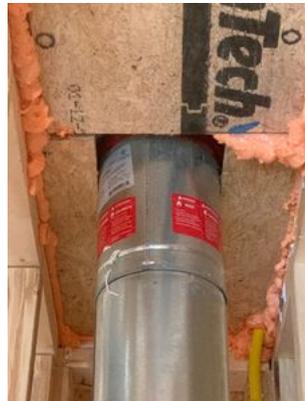
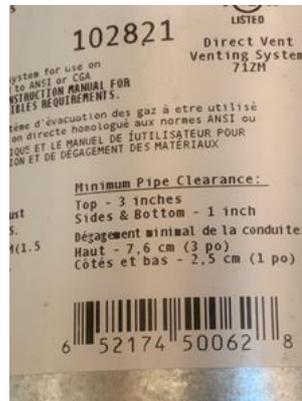
Comment 23

The fireplace vent does not have proper clearance from combustibles where it penetrates the attic. Repair is required as this is a fire safety hazard.

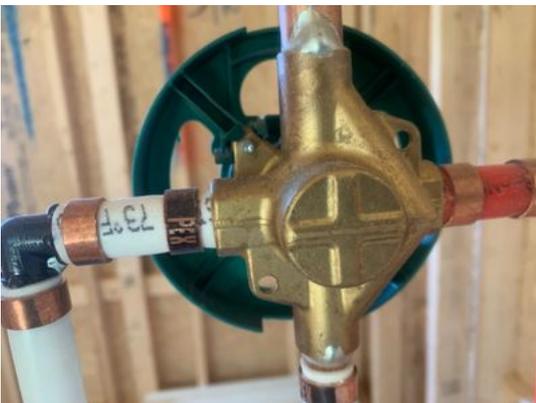
Securing the shower valve body to a 2x4 for long term security of the valve is recommended. There are holes on the valve specifically for this application. Securing the valve will reduce movement and possible tension on fittings and joints which could lead to leaks. Clamps installed on the supply lines tend to loosen over time which may allow the valve to loosen.
